Spectrum

Autumn 2021 | Issue 98

Diagnosing and Eliminating
**Oil Whirl Instability in Steam Turbine
Journal Bearings**

Diagnosing & Eliminating Oil Whirl Instability in Steam Turbine Journal Bearings 15

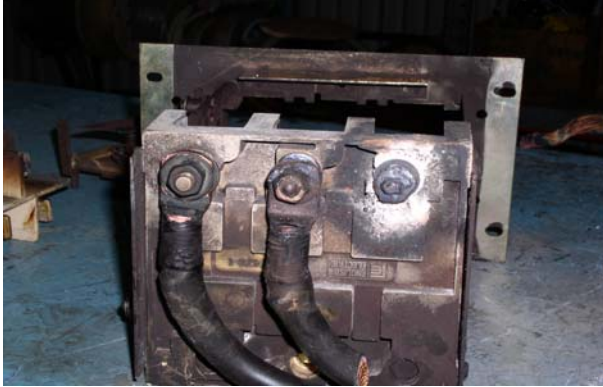
Fig. 1a

Fig. 1b

The CFS shown (in fig. 1) had a DEFECT that eventually caused a fire and a line stop.

The damage to the CFS is the result of arcing that eventually occurred between the Red and Blue phases. This resulted in one of the cable studs burning through.

The root cause of this failure was the poor lug connection practices at the rear of the CFS.

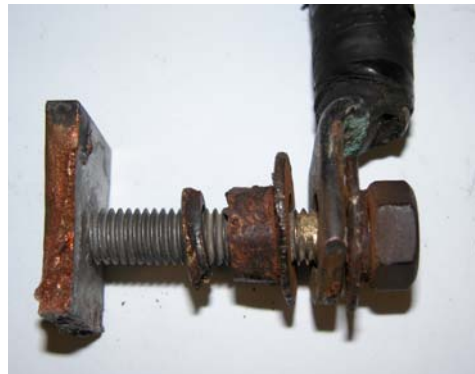
Fig. 3

- The insulating material (fibreglass) is under compression. This is a breach of the wiring rules. Any compression of the insulating material over time will allow the connection to become loose, again resulting in a high resistance joint.

In this instance, there was also deformation of the brass washer to the point where the spring washers were no longer applying any tension to the connection.

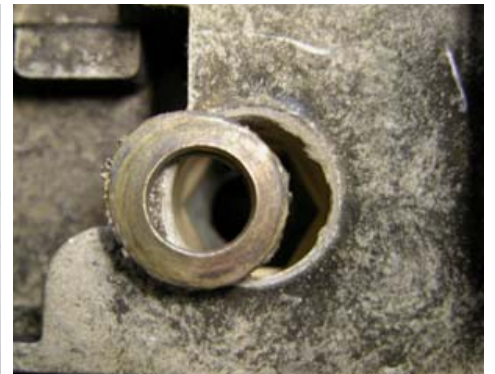
Fig. 4

The picture above (in fig. 3) shows the arrangement of the connections. It consists of a stud (sweated to a copper plate) that passes through a hole in the copper bus and the hexagonal hole in the fiberglass, and exits to the rear of the CFS. Note: The deformed brass washer (in fig. 4) that was only just bigger than the hole.

Incorrect assembly

To avoid another defect, these fasteners must be correctly torqued. The 8mm bolt should be torqued to 9 Nm, and the 10 mm nut should be torqued to 20 Nm. ■

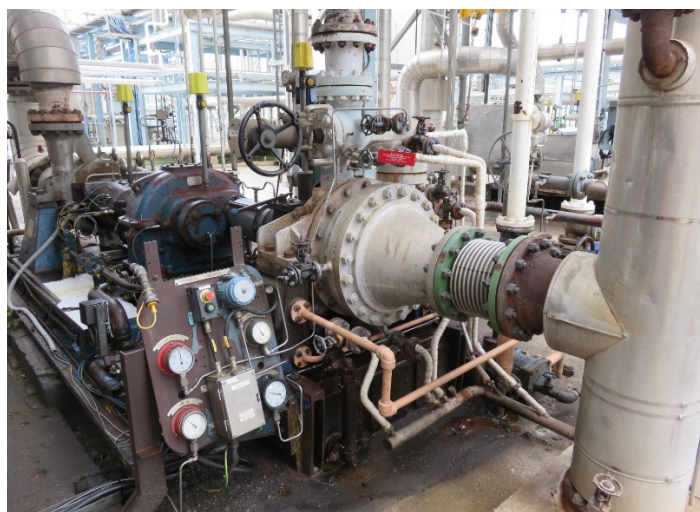
These pumps are Weir TFR 150 single stage centrifugal pumps with an axial flow inducer and centrifugal impeller. They are typically running at 1.3 bar(g) suction and 43 bar(g) discharge, at a flow of 10910 LPM (831.4TPH) of Potassium Carbonate Solution at 108OC. They are driven via a Weir 1-18-2 Horizontal Direct Drive steam turbine, stepped down via a David Brown Type TH double herringbone gearbox with a 2.75:1 reduction. Plain bore cylindrical journal bearings are installed along the whole drive train. To the authors' knowledge, these are the only four units of their kind.

Figure 1. Carbonate Feed Pump G-101-2, Turbine End.

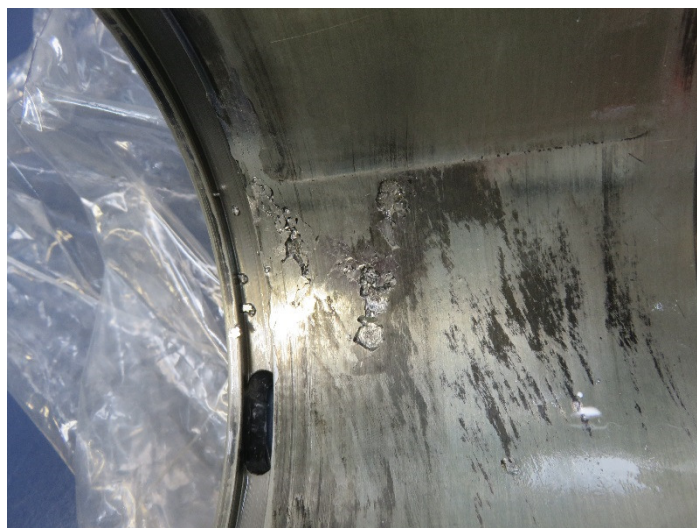
During an equipment survey undertaken on G-101-2, in December 2015, the coupling end turbine bearing was inspected and found to have material loss due to rubbing on the bottom shell near the joint. The decision was made to replace the coupling end bearing only.

Figure 2. Damaged Coupling End Turbine Bearing.

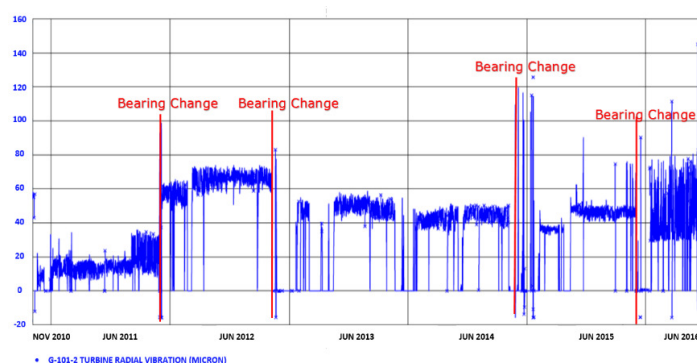
Immediately following the bearing change, there was a significant change in the turbine radial vibration readings, causing intermittent high vibration alarms above 60 microns, and as high as 90 microns in operation. A vibration spectral peak at 0.41x shaft speed pointed to a subsynchronous issue such as auxiliary gear drive or oil whirl. Initially, efforts to control lube oil temperature within a certain range, boosting oil pressure and increasing load on the pump were somewhat successful. However, the problem persisted.

Figure 3. Turbine Bearing Vibration Readings. Nov 2010 - Jun 2016.

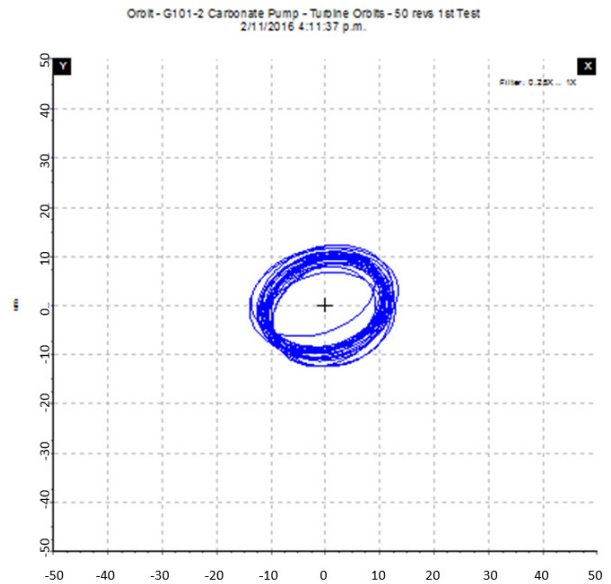
Figure 7. Orbit Plot, Control Bearing @ 8504RPM.

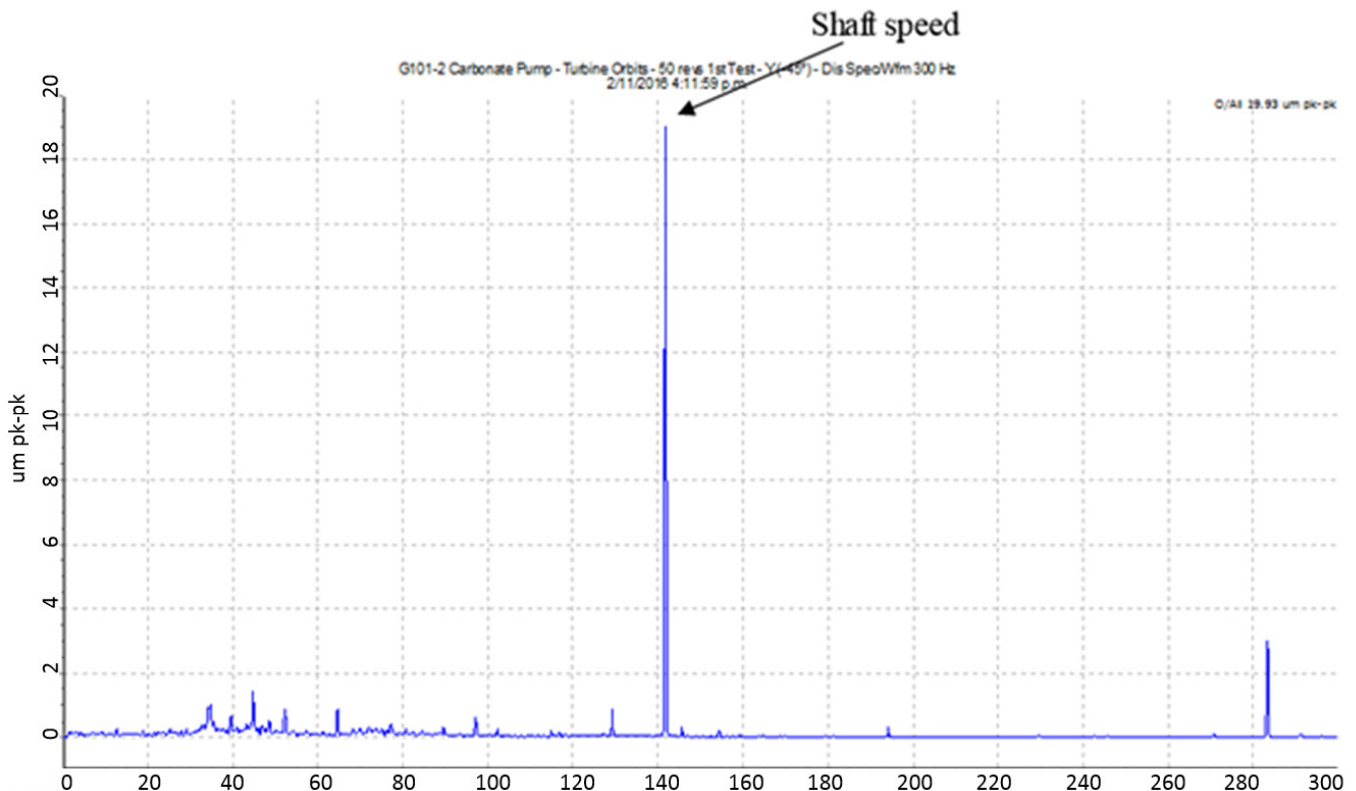
Figure 8. Spectrum 0-300Hz, Control Bearing @ 8504RPM.

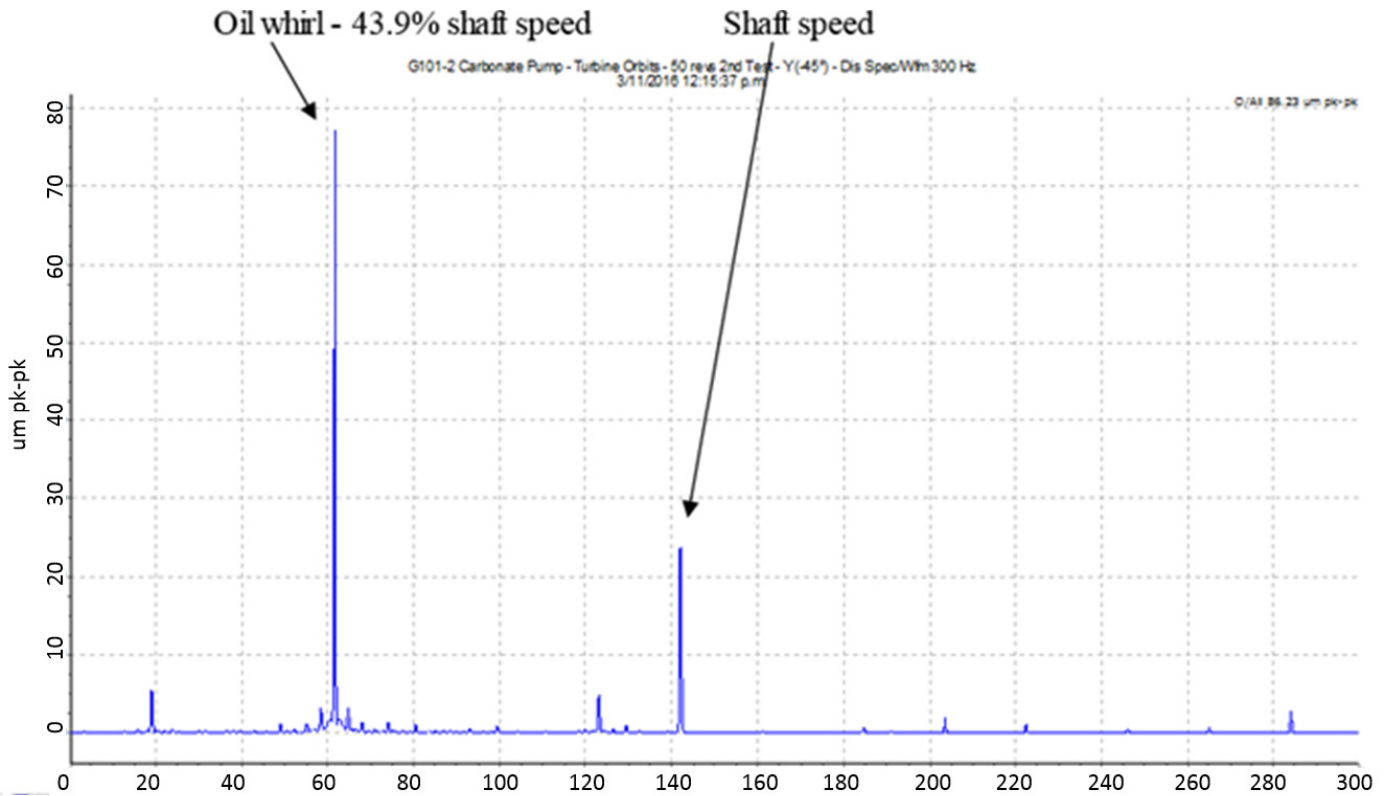
The second uncoupled test results were taken with a proven unstable bearing on the coupling end. This bearing had been known to cause oil whirl issues but was generally comparable in design with the control bearing.

Figure 10. Spectrum 0-300Hz, Unstable Bearing @ 8521RPM.

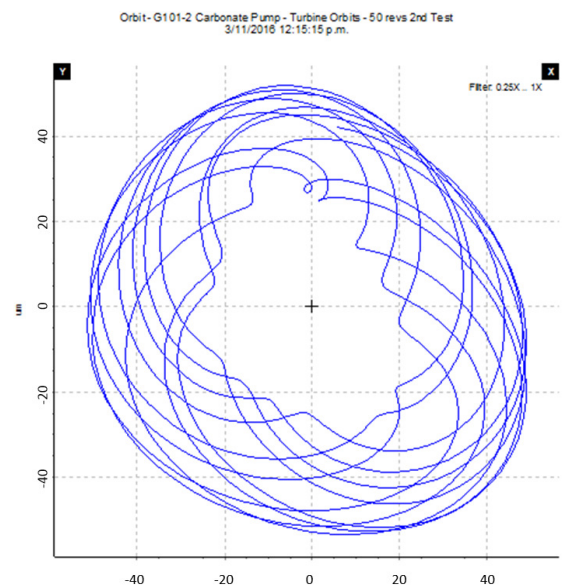
Figure 9. Orbit Plot, Unstable Bearing @ 8521RPM.
