The official journal of the Vibrations Association of New Zealand

Key Guidelines on Condition Monitoring & Reliability of Rotating Equipment

Part 2 – The case studies

What is Soft Foot?

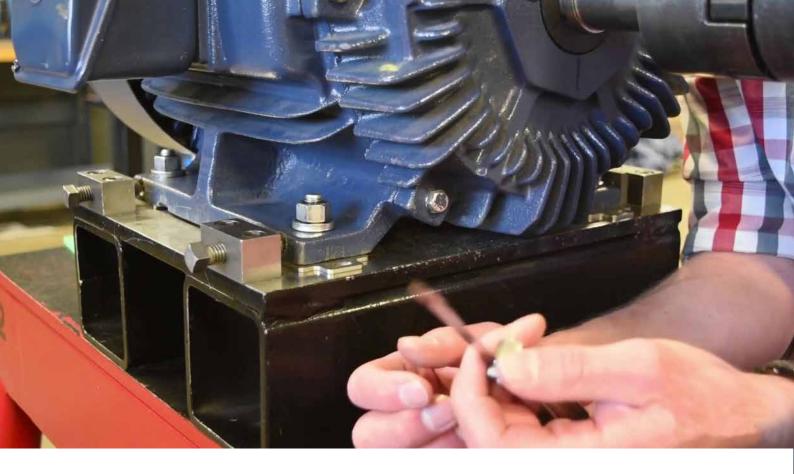
Soft foot is a defect that can occur in many situations, and it has a number of different causes.

along its length. If any of the mounting points are low (or high) compared to the other two, then soft foot will result. The cylinder will fail prematurely and it may be difficult to operate.

Even if the cylinder has only 2 mounting points, soft foot can occur if they are not in the same plane. In the sketch below, imagine tightening the left hand hold down bolts first. This would tend to cause the cylinder to be horizontal. If you then tighten the right hand hold down bolts, then this will cause distortion of the cylinder and its mounts. Consider the self aligning bearing shown below. It can cope with the shaft not being perpendicular to it, but if it is mounted, for example, on a fabricated base which is not flat, then the bearing and housing will be distorted when the hold down bolts are tightened.

In summary, soft foot is a defect that can occur in many situations, and it has a number of different causes. Machines and their bases must always be machined flat and/or shimmed correctly to avoid soft foot. If this is not done, the machine life will be significantly reduced.

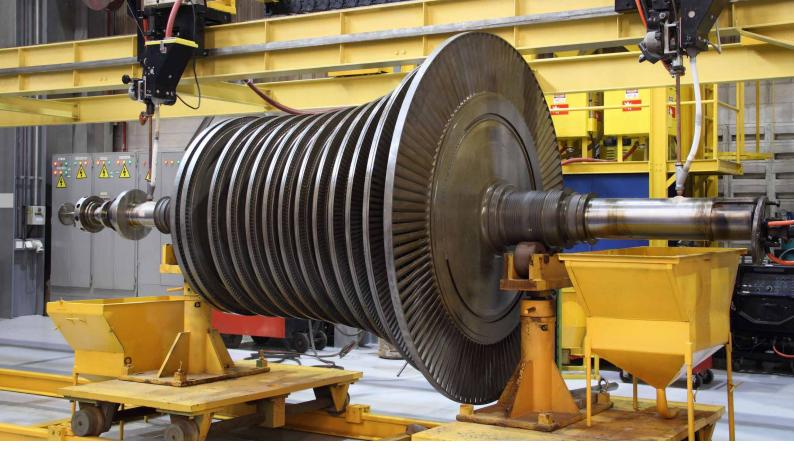
When the temperature reduced to normal level, the vibration was also reduced to normal patterns. All parameters were returned to normal levels and there was no sign of damage or malfunction.

the temperature limit whereas the final discharge temperature just shows a small rise (even not showing an alarm for the discharge temperature) due to cooling effects of the incoming large volume of side-stream flow. For an alarm case when the assessment is all compressor operating parameters are still within allowed limits, the general recommendation is "do not shutdown compressor". For example, in case of an increase of a gas suction temperature for a short time when no parameter passes its limit, the recommendation is to continue operation unless there is a reason or a reasonable evidence for a shutdown.
