Spectrum

Autumn 2023 | Issue 107

Problems and Solutions with Magnetic Stator Wedges

Torsional-Lateral Coupled Vibration in Integrally Geared Compressors

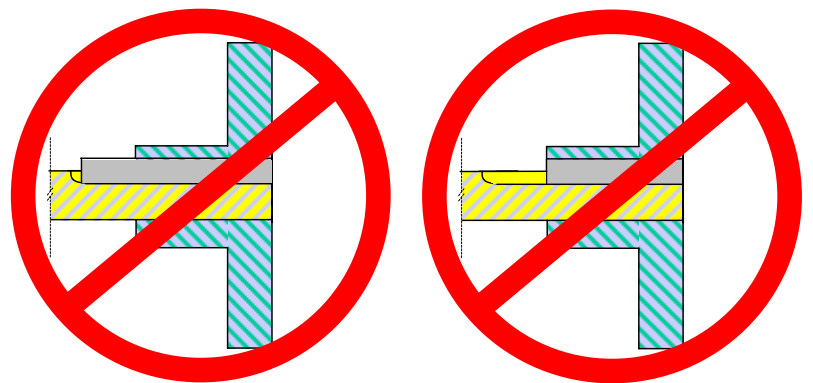
Fig. 3

In this way, the mass of the proud section of key is equal to the mass that is missing from the keyway. These types of key configurations (see fig. 3) are NOT ACCEPTABLE because they are not balanced!

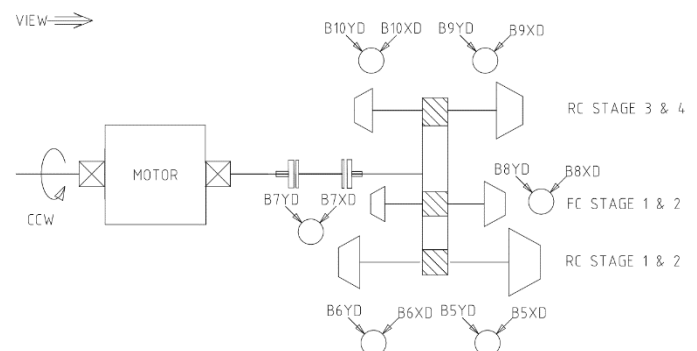
Figure 1 - Machine train and transducers layout showing existing shaft vibration probes installed at each bearing. Note that there is no vibration and keyphaser sensor installed at motor.

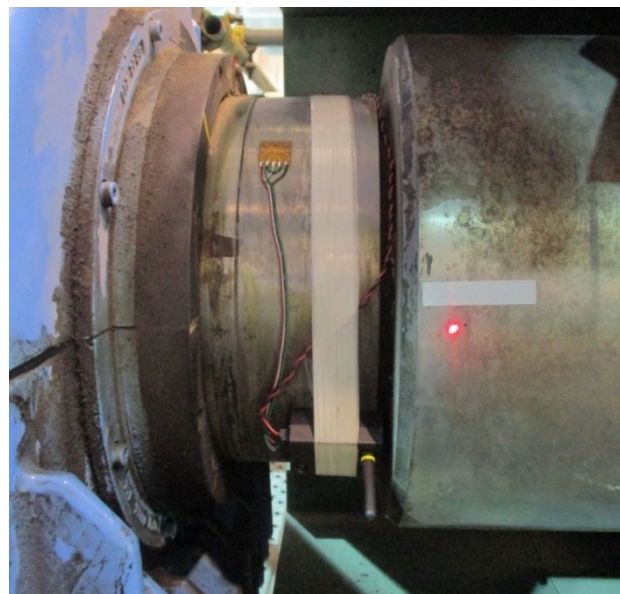
Figure 2 - Strain gauge and transmitter installation at motor shaft.

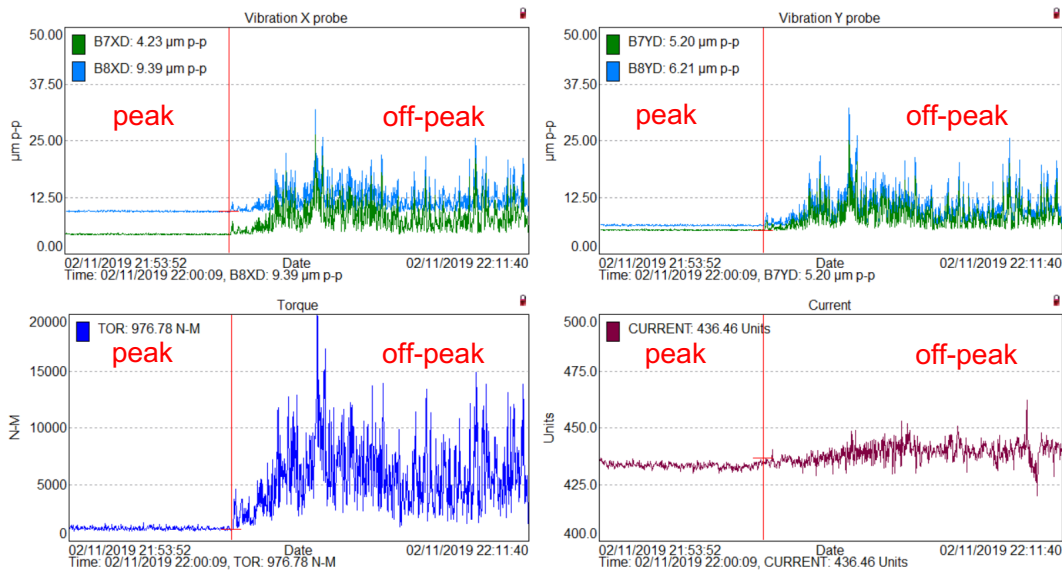
Figure 3 - Trend plots data correlation of vibration data measured at FC rotor, dynamic torque, and power supply current of motor during peak and off-peak operation period.

There was also noticed that fluctuating torque and vibration is also coincident with fluctuating power supply current to the motor and it was predominant at off-peak operation period (*see figure 3*). It was suspected that fluctuating current could induce oscillating air-gap torque at the motor, therefore, fluctuating torsional vibration. There is clear evidence that fluctuating torque and vibration disappear when dynamic current is smooth (or less fluctuation).

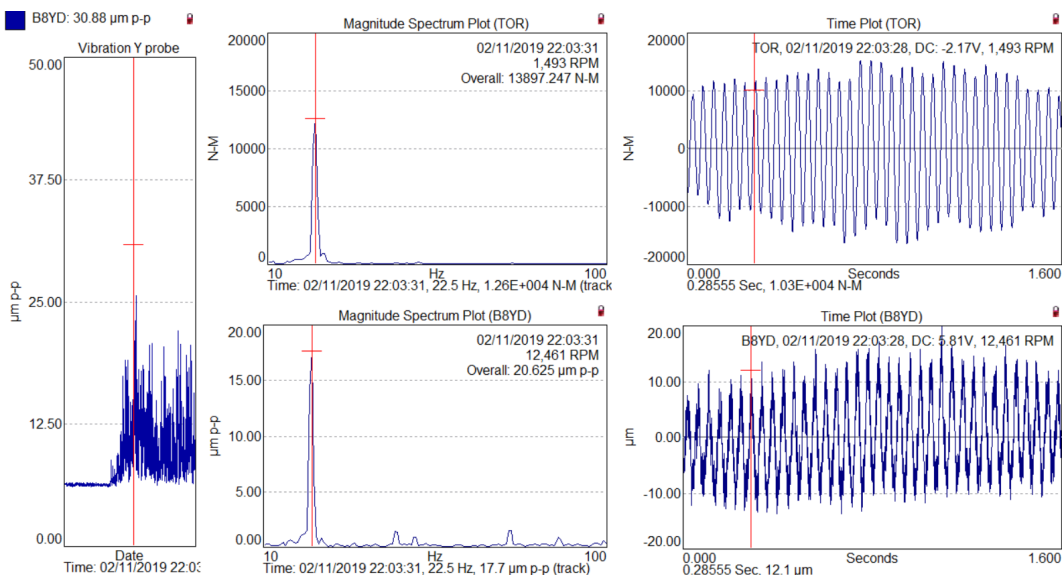
Figure 4 - Waveform and spectrum data of vibration data measured at FC rotor and dynamic torque during off-peak operation.

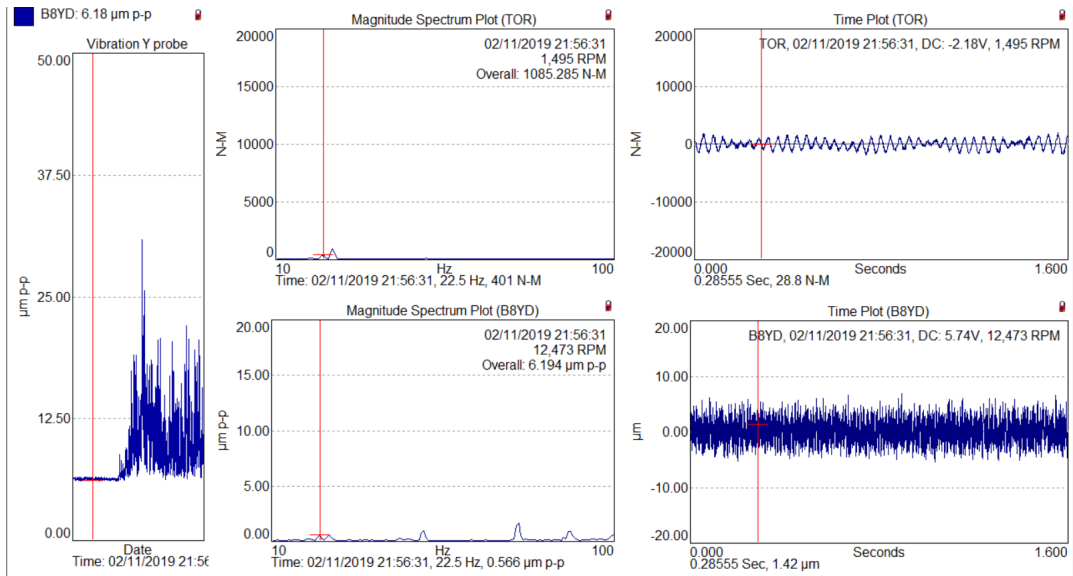
Figure 5: Waveform and spectrum data of vibration data measured at FC rotor and dynamic torque during peak operation.

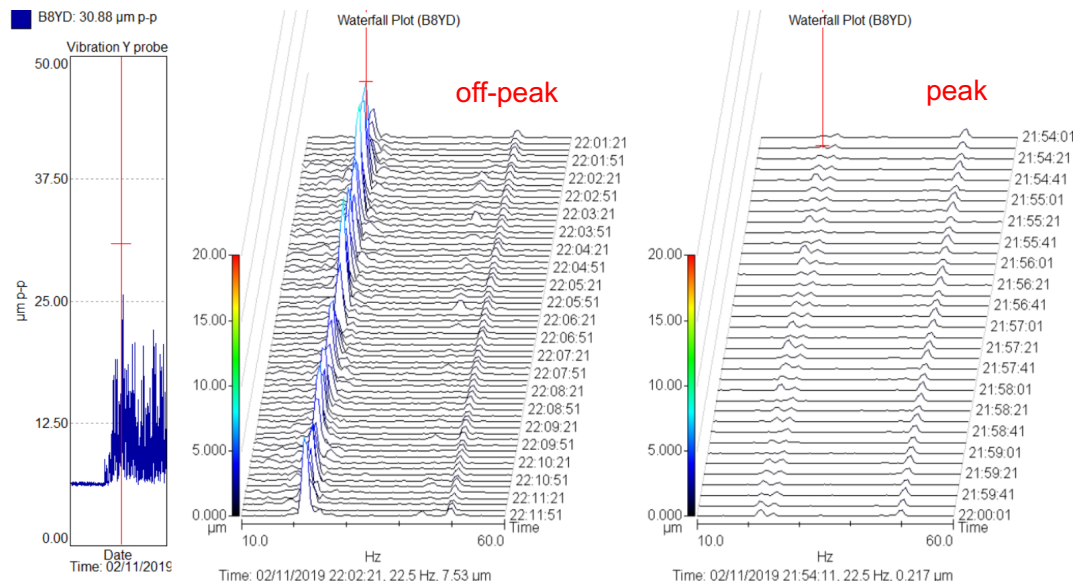
Figure 6 - Waterfall plots of vibration spectrum comparison between peak and off-peak operation period.

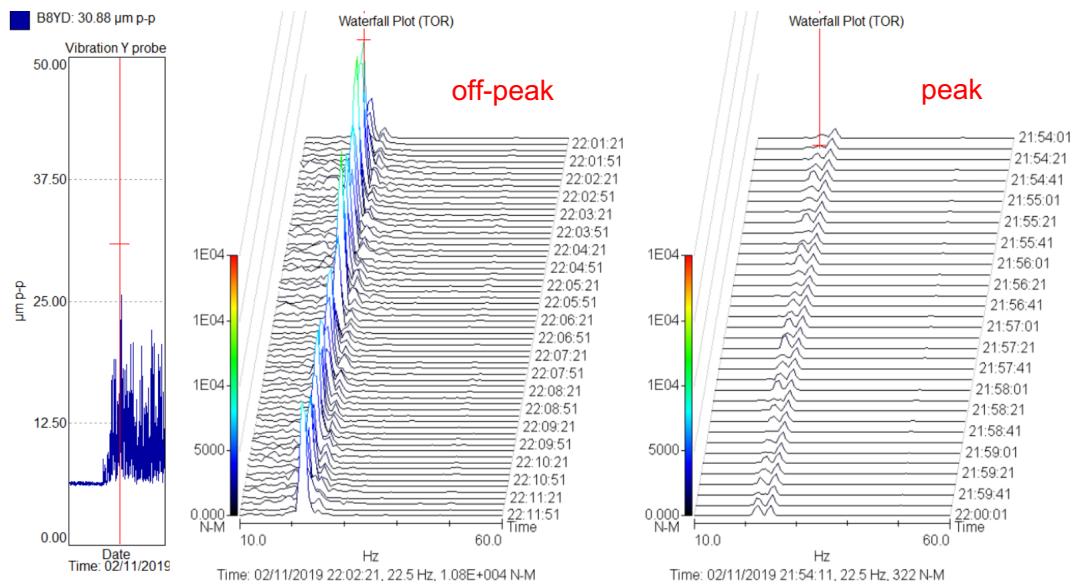
Figure 7 - Waterfall plots of dynamic torque spectrum comparison between peak and off-peak operation period.

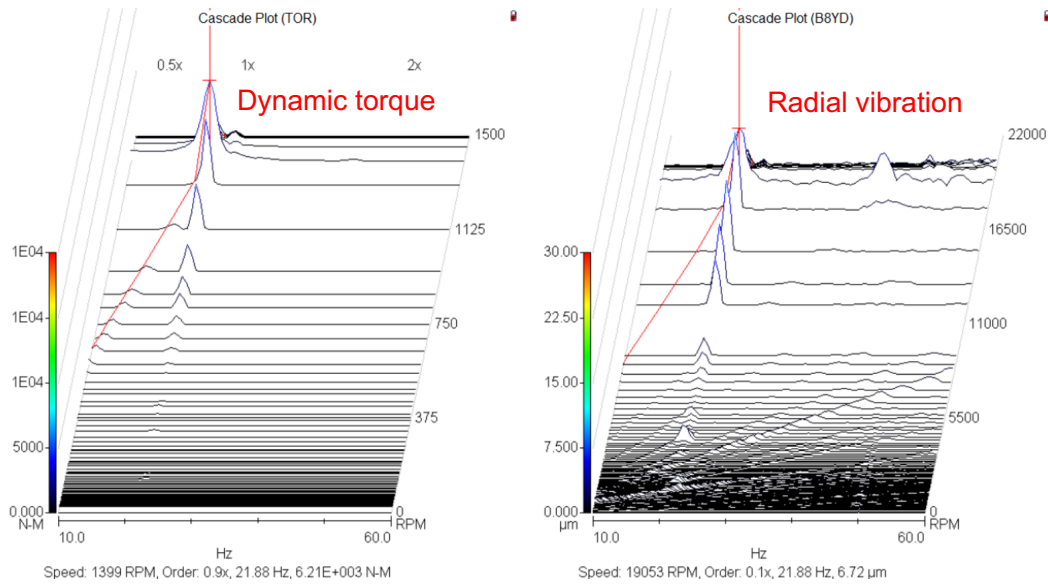
Figure 8 - Dynamic torque (left) and vibration of FC rotor (right) spectrum versus machine speed during transient.

shutdown is reviewed and found that 21.88 Hz frequency component revealed constant frequency with machine speed independent when the unit ran down for both torque (torsional vibration) and radial vibration (see figure 8). This is a symptom of resonance as it is suspected torsional natural frequency (TNF) is excited by torque oscillation of motor rotor. This is very close to calculated TNF of drive train at 1278 cpm (or 21.2 Hz) with 14.29% separation margin from motor operating speed, refer to Table 1.

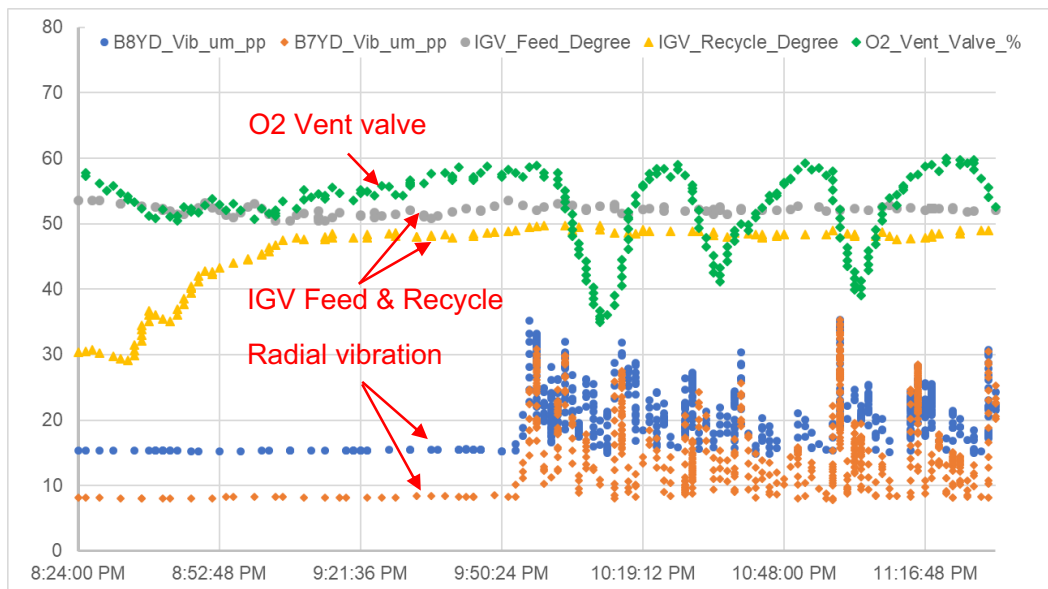
Figure 9 - Trend plots of multiple operating variables correlating with vibration data measured at FC rotor during peak and off-peak periods.

cause of current fluctuation should be identified. Relevant operating parameters is reviewed (Figure 9). and found that compressor load parameters are constant or no significant change/different between peak and off-peak period, for example, IGV feed and recycle, suction/recycle flow, etc. This is concluded that fluctuating current is not due to compressor load fluctuation.

However, it was found that oxygen vent valve operation (green color curve) has significant relationship with fluctuating radial vibration amplitude measured at FC stages (blue and orange color curves).
