Spectrum

Winter 2025 | Issue 116

Steam turbine blade breakage – maintenance + monitoring challenge

Pressurised gas hazard
in internal cavities

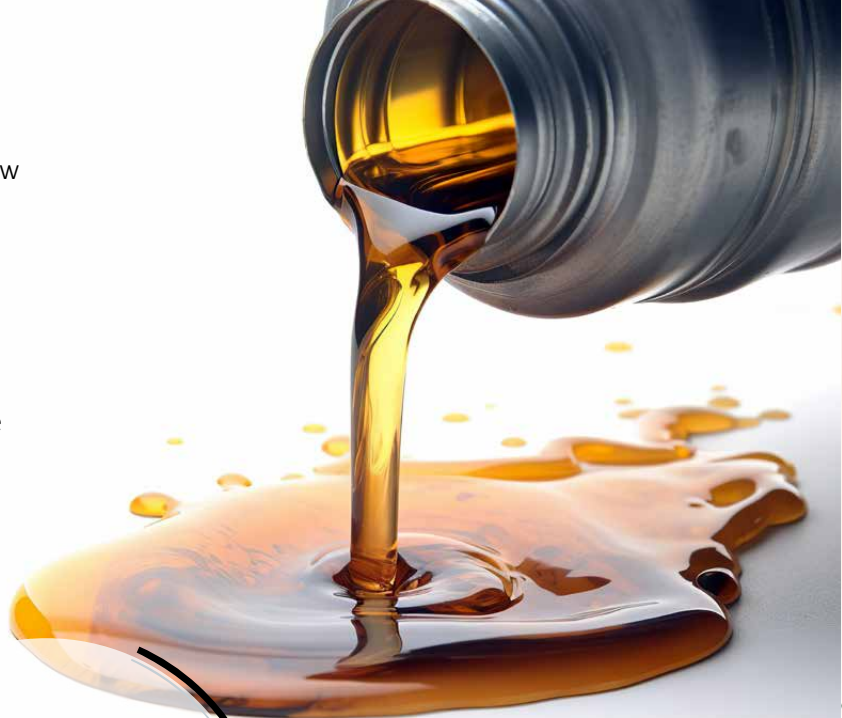
When the sample is taken, ensure the tube to the machine is clean and only use the laboratory supplied bottles.

The sampling point and method is just as important to the result as the oil condition itself. This is an easy point of ingress, that if not done correctly, can distort your analysis results. The point at which oil is collected from is important and should be representative of the oil in the machine. The most representative and reliable location would be a dedicated sampling port that is likely located midstream on the machine.

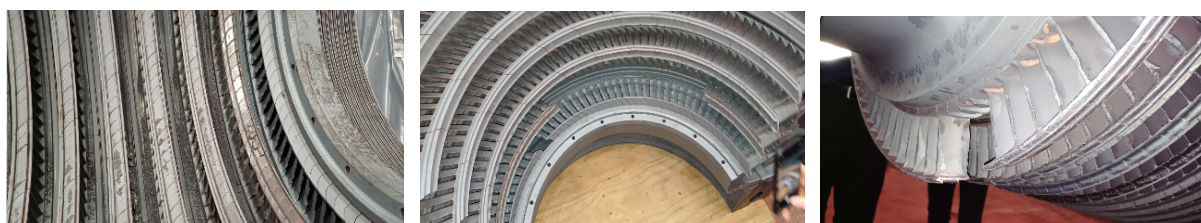
Figure 6. IP casing bottom section (left), top stationary blades (middle), IP shaft (right).

After finalizing that the IP turbine section was the source of the problem, the outer and inner casing were removed to inspect the turbine. An extensive amount of damage was discovered, as shown in Figure 6:

- Row one stationary blades in the top diaphragm had a blade package missing
- The turbine rotor had three separate blade packages missing and extensive rubbing wear on numerous other stages
- The second-row top stationary blades had a 90° arc of missing blades
- There was a lot of metal debris and damage to the stationary blade in the casing bottom half, where there were blade pieces no larger than 5 mm found. ■

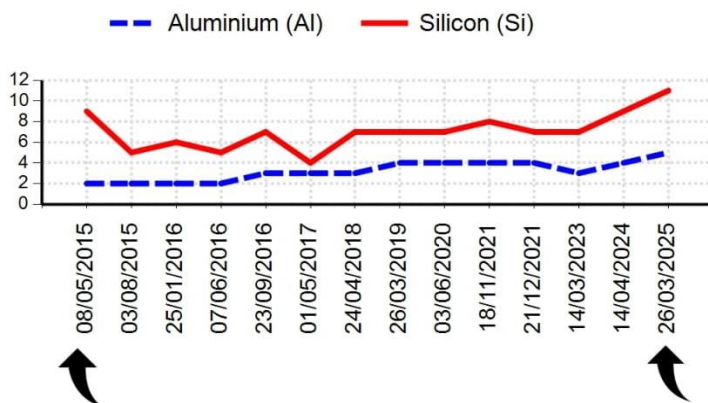
Oil Analysis snapshot of Duolec Industrial gear oil LE1605 (60 Litre) in service for 10 years, filtered once using LENZ's offline filtration trolley at 3 micron filter.

All wear rates normal. Abrasive and other contaminant levels are acceptable. Viscosity within specified operating range. Action: Resample at recommended service interval to further monitor. Note: Sample Information Form states: Last oil change 25/05/2011.
